RIVER WALL DAM

PHASE I INSPECTION REPORT

NATIONAL DAM SAFETY PROGRAM

National Dam Safety Program. River Wall
Dam (NJ-00547), Passaic River Basin,
Pequannock River, Passaic County,
New Jersey. Phase I Inspection Report.

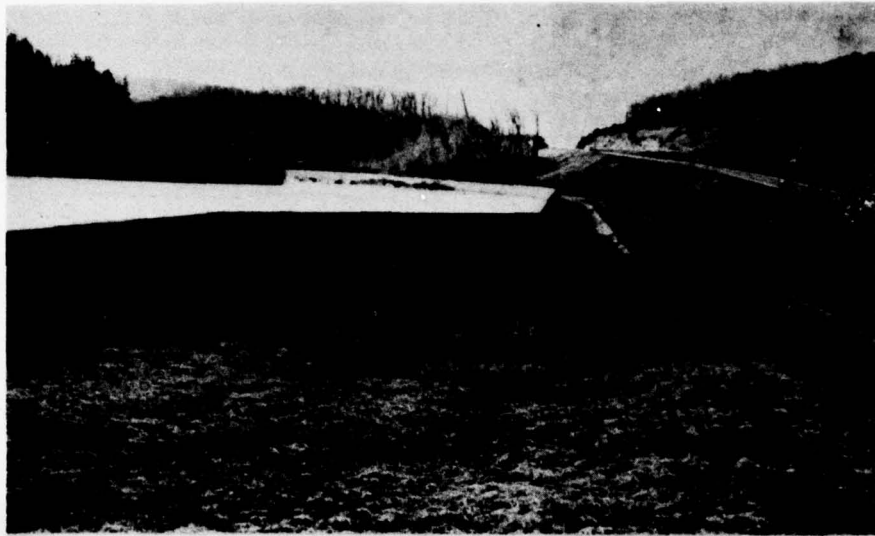
No seepage or leakage could be detected at the toe of the river wall because of backfill at the toe. The concrete gravity section shows some evidence of minor seepage through shrinkage cracks located approximately in the middle of the monoliths from Sta. 13 + 00 to Sta. 18 + 60. The seepage areas were dry, but mineral deposits coat the wall at the cracks.

Photo 3 - View of north side of wall taken from right abutment. White spots on face of wall are seepage areas. Drainage ditch, abandoned tracks, and Route 23 can also be seen (Photo taken May 1, 1978)

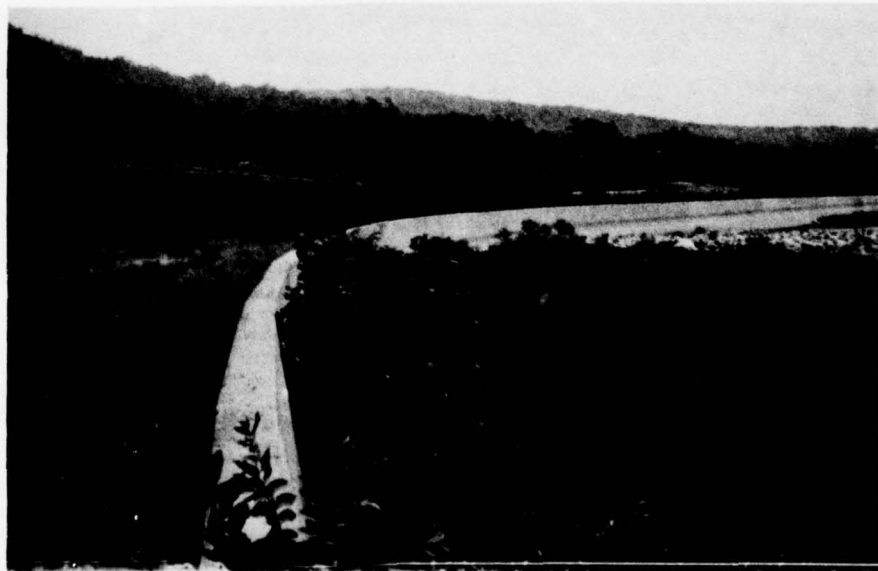
Photo 6 - View of reservoir side of gravity wall looking east from crib wall, showing heavy vegetation growth (Photo taken August 3, 1978).

(5) Remove all brush and scrub trees at the riverward face of the wall and replace with suitable ground cover, to prevent undermining of the wall footing.

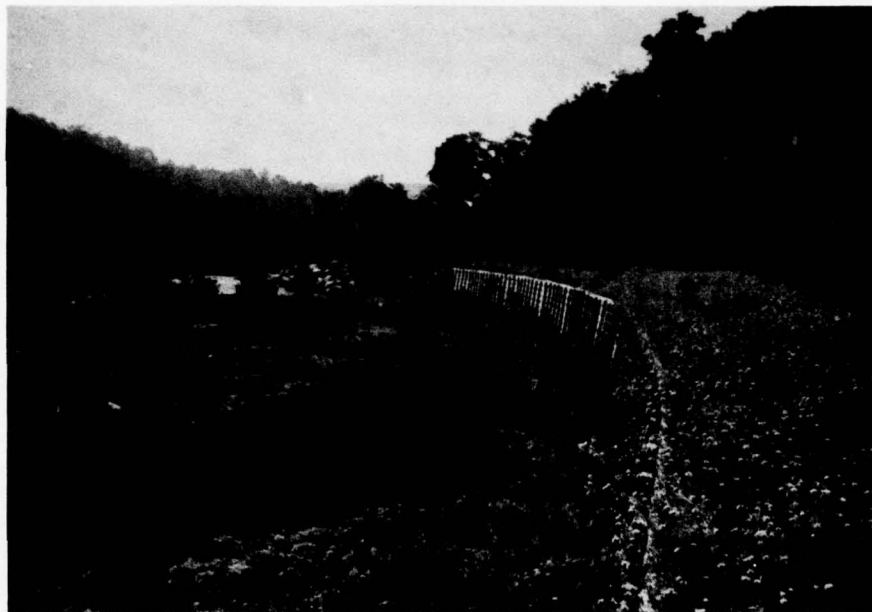
Photo 7 - View of crib wall and embankment from gravity wall. Heavy vegetation on riverward side of wall can also be seen. (Photo taken August 3, 1978).

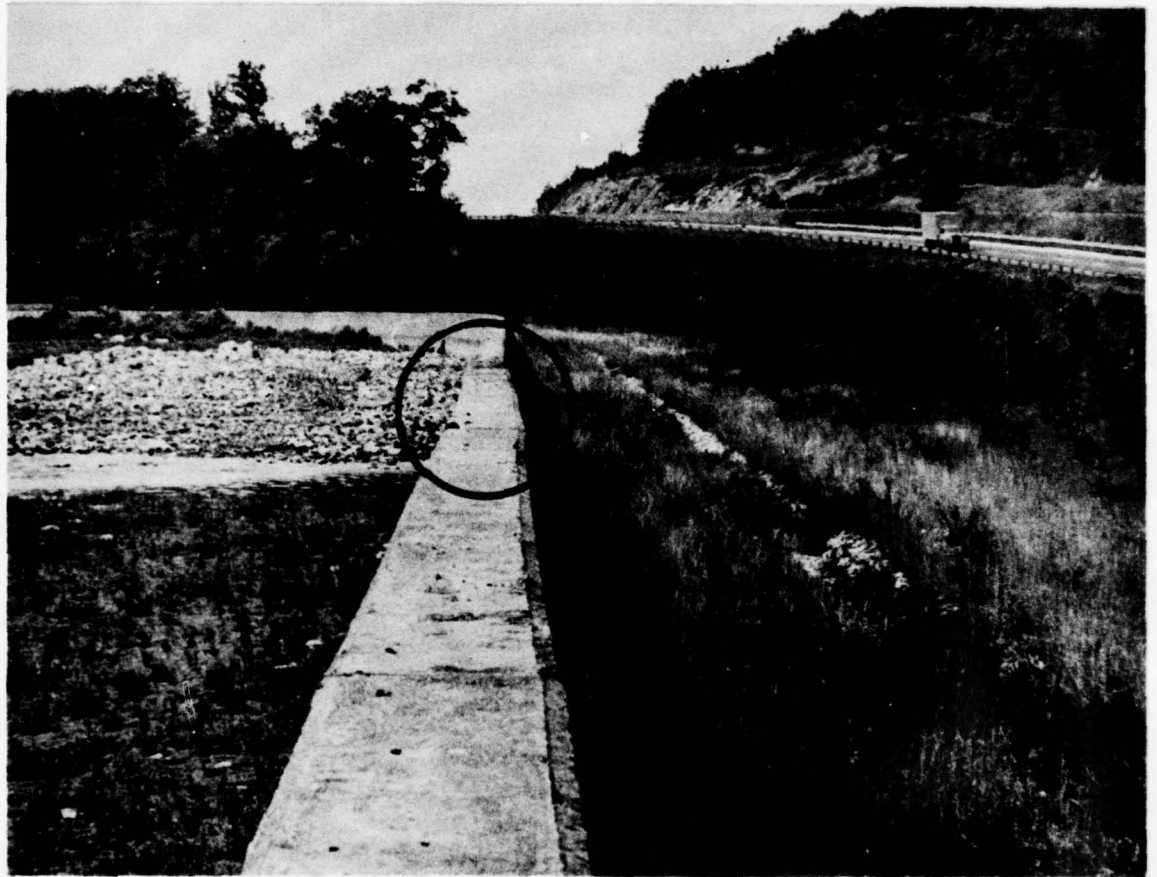
At approximate Sta. 16 + 50±, there is a horizontal misalignment of the river wall in the direction away from the reservoir which can be detected by sighting along the top of wall. This misalignment is at approximately the same location as the joint leakage. The origin of this misalignment should be investigated to determine if this condition and the monolith joint leakage are related.

Photo 13 - View of top of wall looking west showing horizontal misalignment of monolith. (Photo taken August 3, 1978).

Check misalignment at approximate Sta. 16 + 50.
Determine cause.

The study to determine the cause of horizontal misalignment at approximate Sta. 16 + 50 and to find out if there is any correlation between the misalignment and the joint leakage should be undertaken and completed within 6 months. Similarly, the foundation soils data should be developed within 6 months.
